HP Pavilion 11 x360 Fan Replacement

Fix overheating issues by replacing your fan.

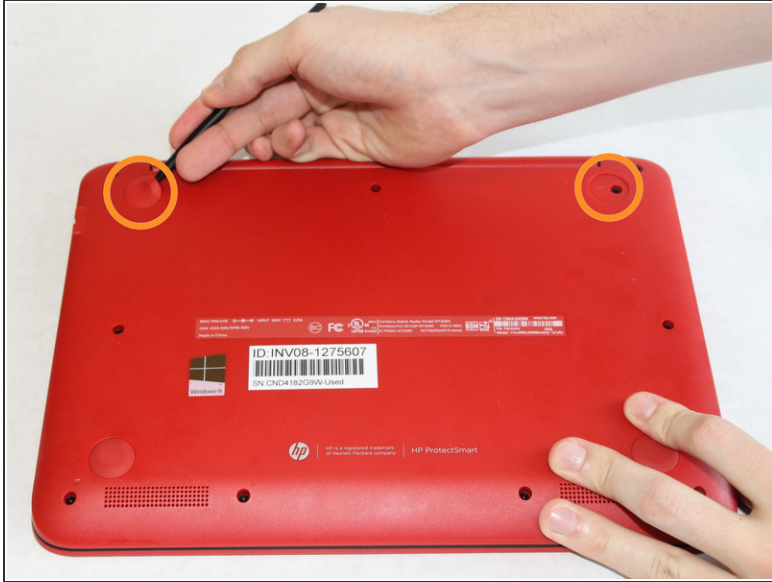
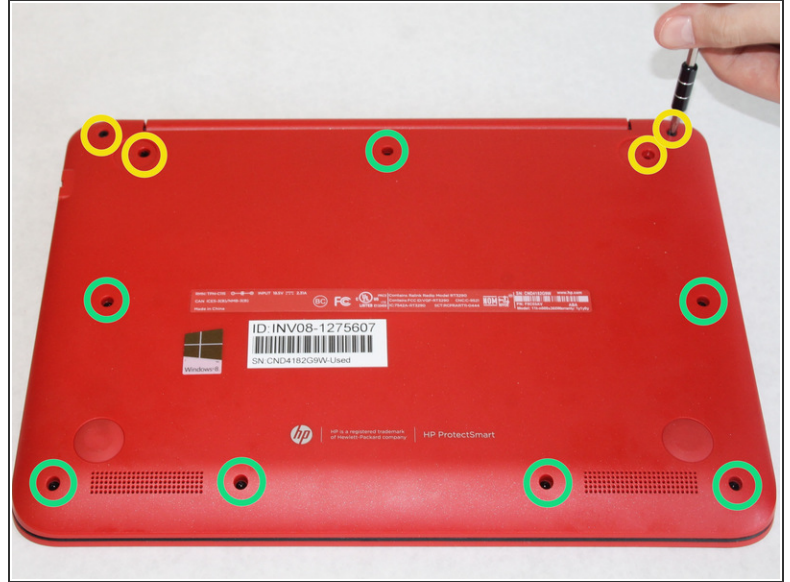
Step 1 — Remove Screws

- Use the spudger to pry off the two rubber feet near the hinge of the laptop. This will reveal two hidden 9mm screws.
- You must remove eleven screws.
 - Four 9mm screws with the PH0 screwdriver.
 - Seven 6mm screws with the PH0 screwdriver.

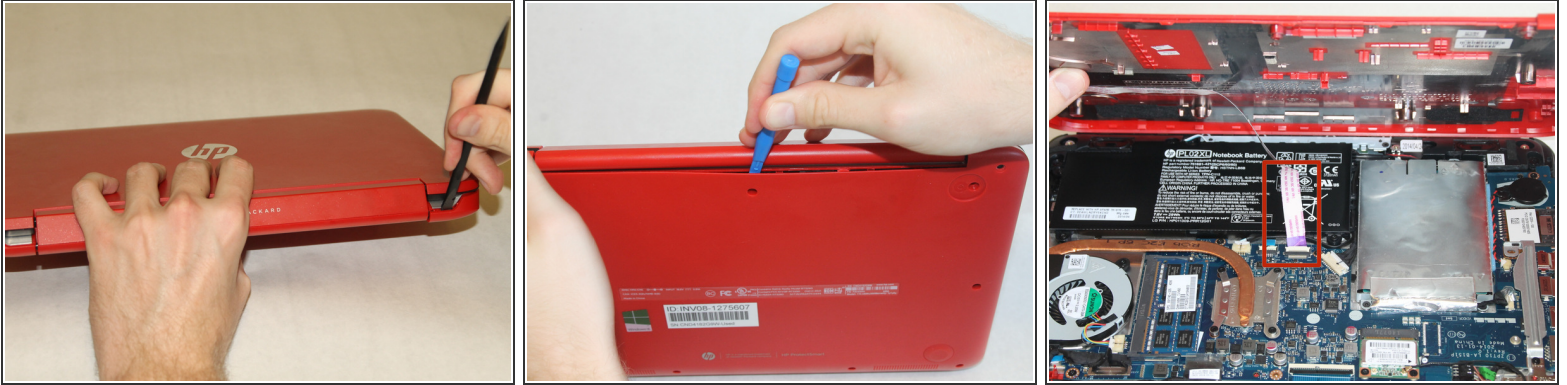
Step 2 — Remove Backing

- Use the spudger to pry the corners of the laptop near the display hinges.
- Pry around the seam of the laptop with the plastic opening tool until the backing begins to pull apart.

When you lift the bottom cover, there is a cable connected between the motherboard and the bottom cover. Be careful not to pull the cable loose!

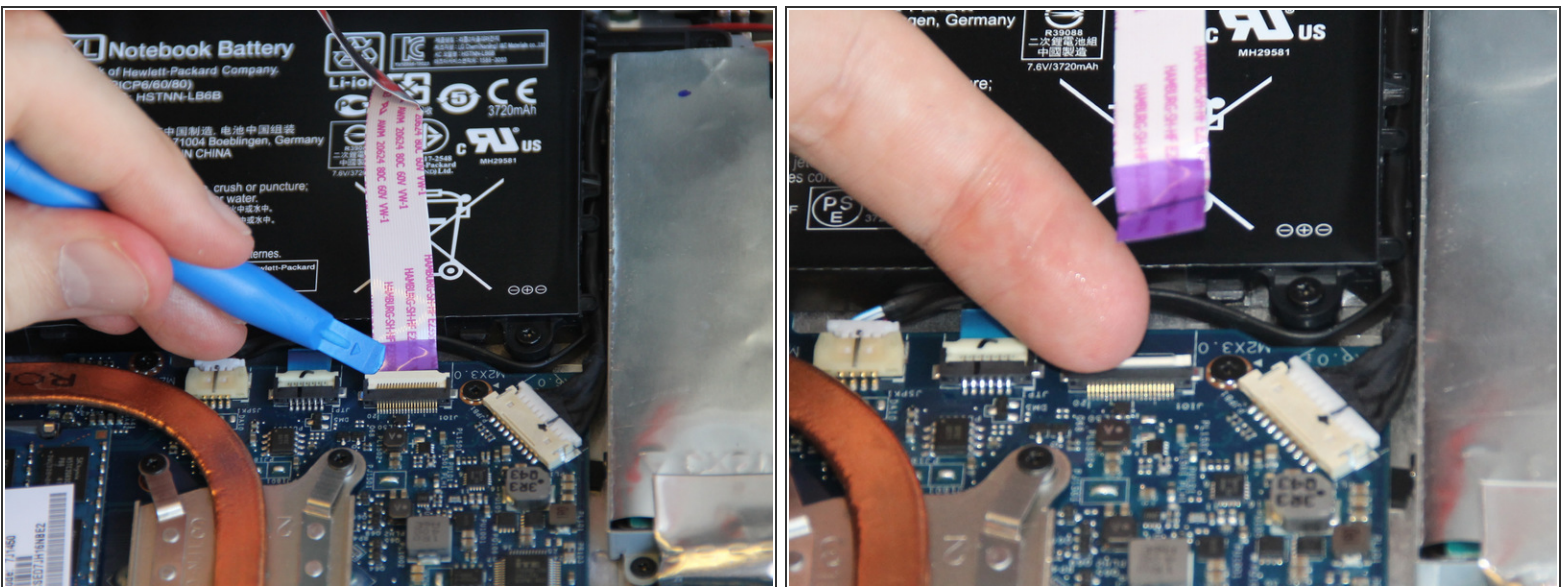
Step 3 — Detach Cable

- Use the plastic opening tool to lift the white tab up at the connection.
- Pull the cable outwards.

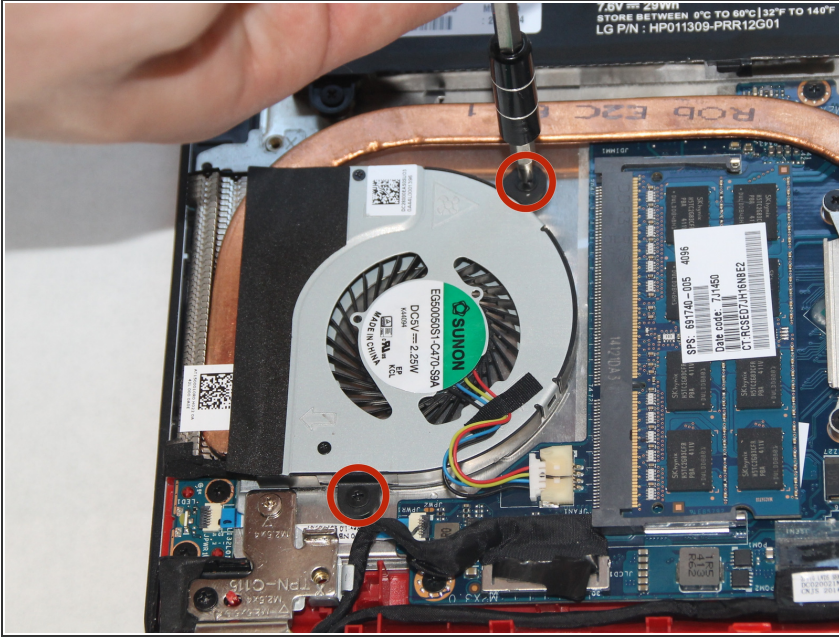
Step 4 — Remove Screws

- Remove the two 3mm screws with the PH0 screwdriver.

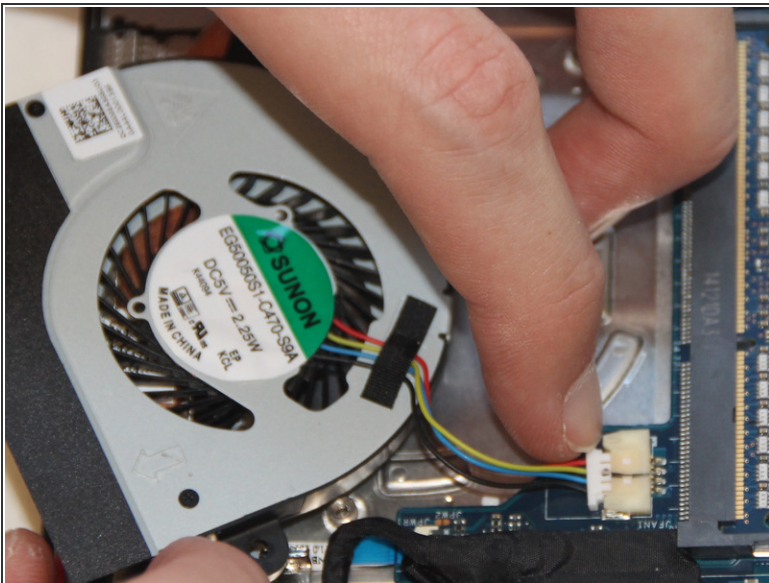
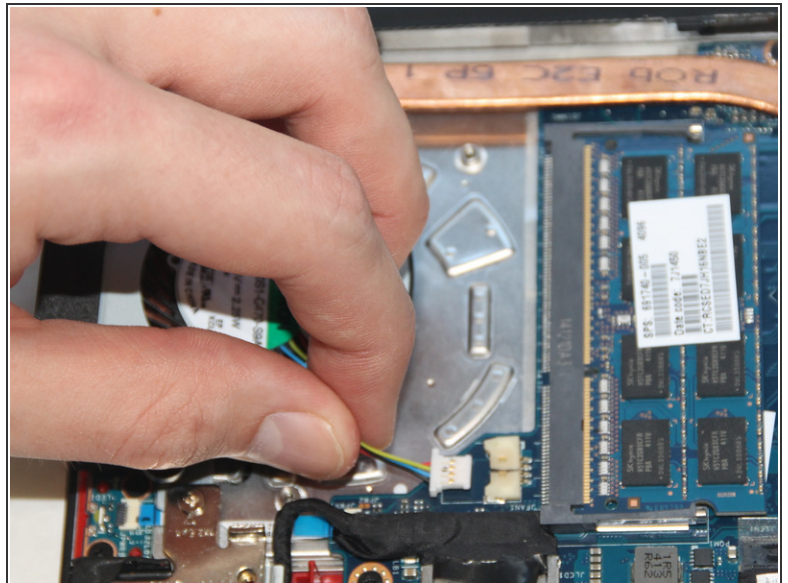
Step 5 — Disconnect Cable

- Use your fingernails to slowly loosen the fan connection cable.
- After the cable is slightly pulled from the connection, grab the cable and pull it outwards.
